Manhole Inspection Summary

Manhole # S47E2_023MH

Record Plat: **47E2** Node: **023** Status: **New Manhole (Not in GIS)** Insp Date: **4/18/09 12:00 AM**

Location Address: **4200 Grace Morrison Alley**

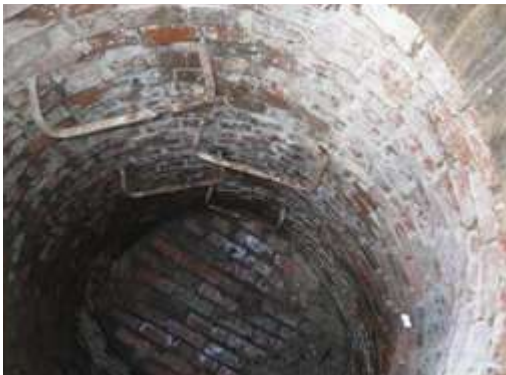
steps

Count: **4** Missing: **0** ☐ Corroded

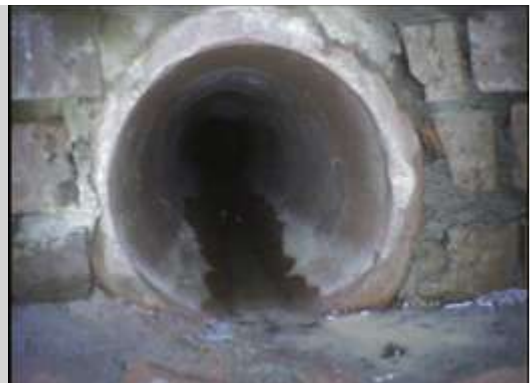
12 O'Clock Outflow

8 in. Circular Gravity Sewer
Pipe Out @ 12 O'Clock

Deposits: ☒ None ☐ Mud ☐ Sludge ☐ Debris ☐ Grease

Infiltration: **None** Pipe Seal Cond: **Sound**
